ORNL/TM-7166

Corrosion of a Stainless Steel Waste Heat Recuperator

J. I. Federer
V. J. Tennery

Date Published: June 1980

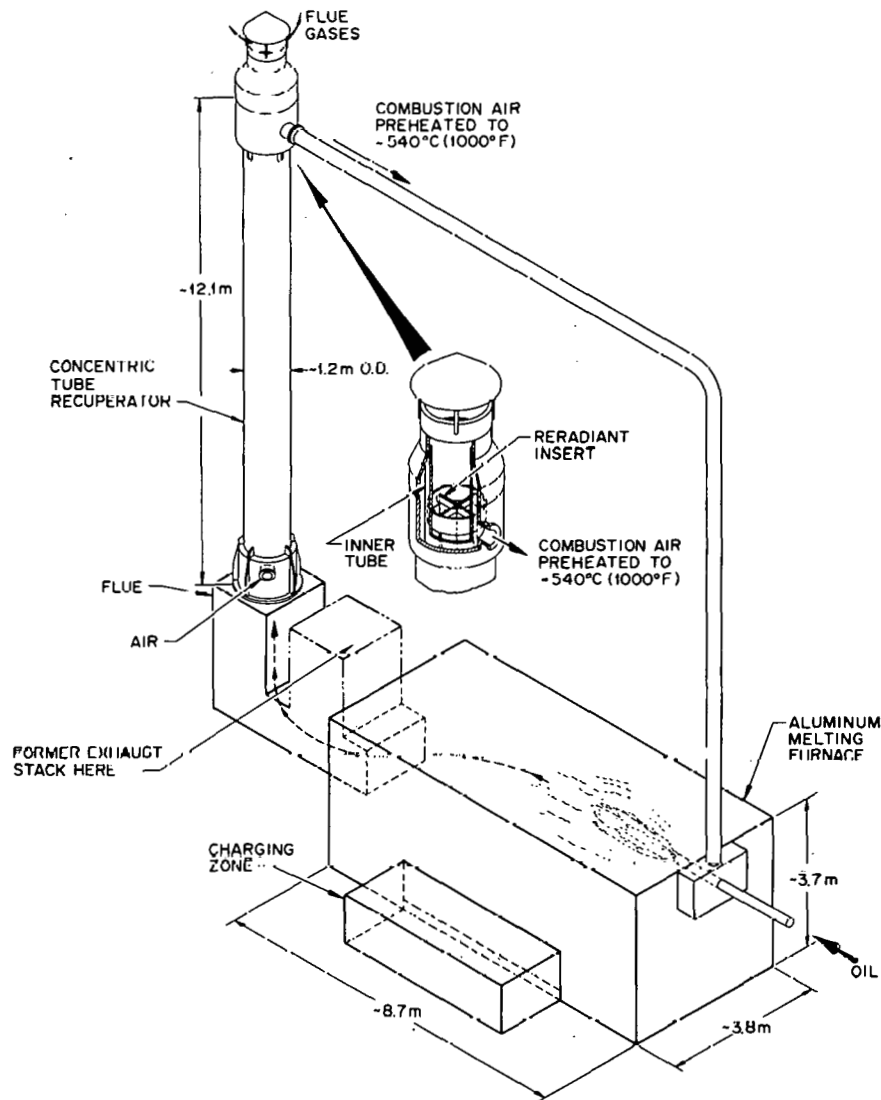
ORNL-DWG 79-15974

Figure 1 illustrates the recuperator attached to the exhaust flue of the aluminum-melting furnace. The effective height of the recuperator was 12.2 m (~40 ft). The total height, including the adaptor section and dome top, was 14.2 m (~47 ft). The basic recuperator consisted of two vertical, concentric tubes. The outer tube was 1.17 m (~46 in.) in inside diameter with a 6.35-mm-thick

Fig. 1. Stainless steel recuperator on an aluminum-melting furnace.

Four reradiant inserts were positioned inside the partition wall as shown in Fig. 1. Each insert was 11.7 m (~38 ft) high \times 0.45 m (17.5 in.) wide \times 5 mm (0.1875 in.) thick. The inserts extended almost the effective length of the recuperator. The four inserts were arranged in a cross pattern with 90° included angles. During operation the inserts radiate heat to the inner wall, thereby increasing heat transfer from the hot flue gases. The partition wall and the reradiant inserts were constructed of type 309 stainless steel. The inserts were held in a 90° cross by Incoloy 800 H angle brackets bolted to the inserts.

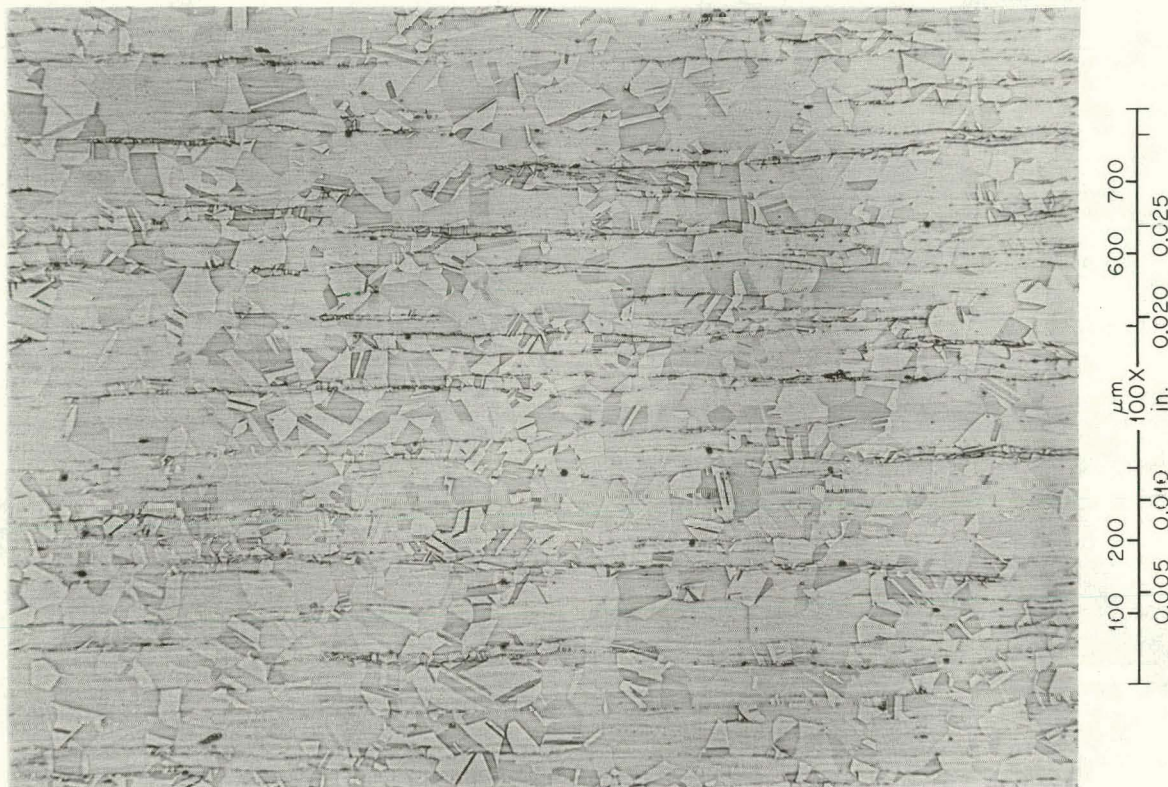
The microstructure of the type 309 stainless steel used in construction of the recuperator is shown in Fig. 6. During prior fabrication into sheet, the nonmetallic inclusions typically contained in this steel elongated into thin sheets. These inclusions, which are apparent as dark horizontal lines in Fig. 6, do not significantly affect the mechanical properties or corrosion behavior of the steel. The

Fig. 6. Microstructure of type 309 stainless steel used in fabrication of recuperator.

steel was probably recrystallized during fabrication, but the angular grain structure suggests that further fabrication occurred below the recrystallization temperature.

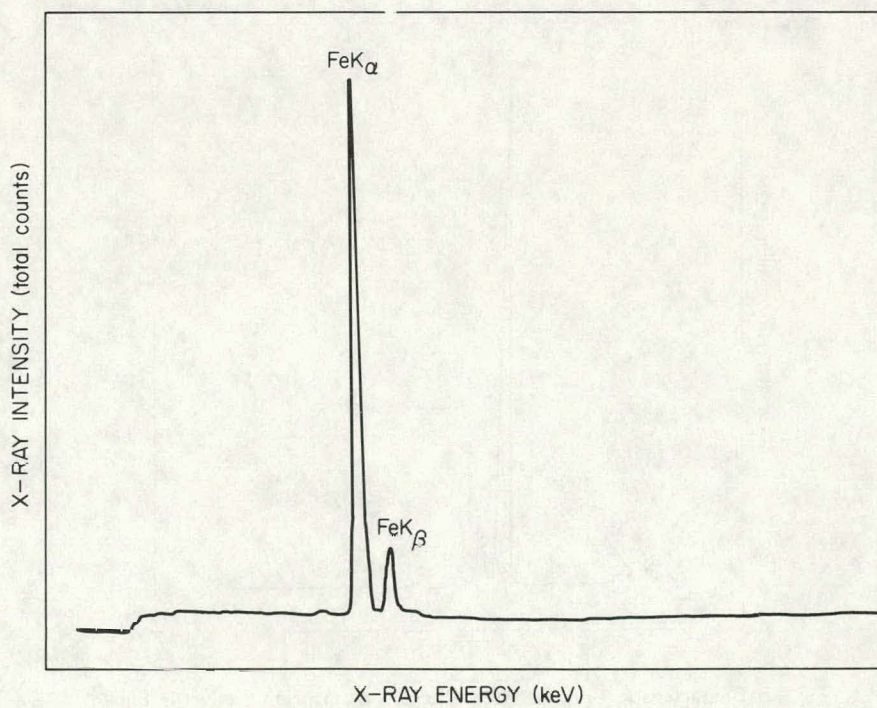
ORNL-DWG 80-8652

Fig. 10. Characteristic x-ray spectrum of region A corrosion product in Fig. 9.

concentrations of the elements. These results, summarized in Table 5, show that the corrosion product was nonhomogeneous in composition. The electron microprobe used in this work could not detect elements with atomic number less than 11 (sodium); therefore, oxygen was not detected. X-ray diffraction results, which were presented previously, showed the presence of iron and chromium oxides, so oxygen was certainly present in abundance. Table 5 shows that sulfur was found in substantial amount in several regions in the corrosion product. Since the concentration of sulfur was quite small relative to Fe, Cr, and Ni in the original type 309 stainless steel (see Table 2), the relatively high concentration of sulfur in the corrosion product was undoubtedly derived from the fuel oil combustion products and oil residues on scrap metal.

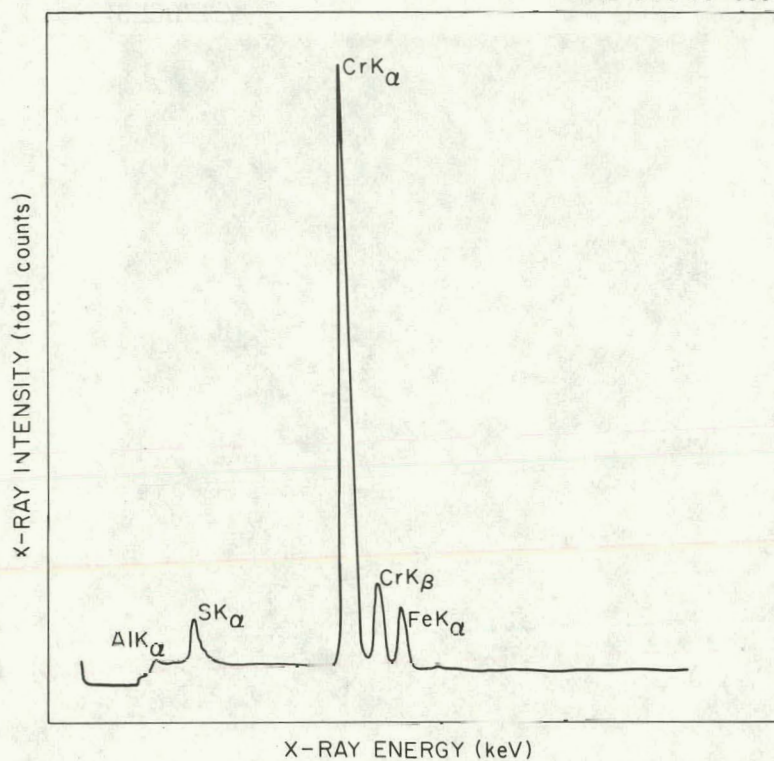
Fig. 11. Characteristic x-ray spectrum of region B corrosion product in Fig. 9.

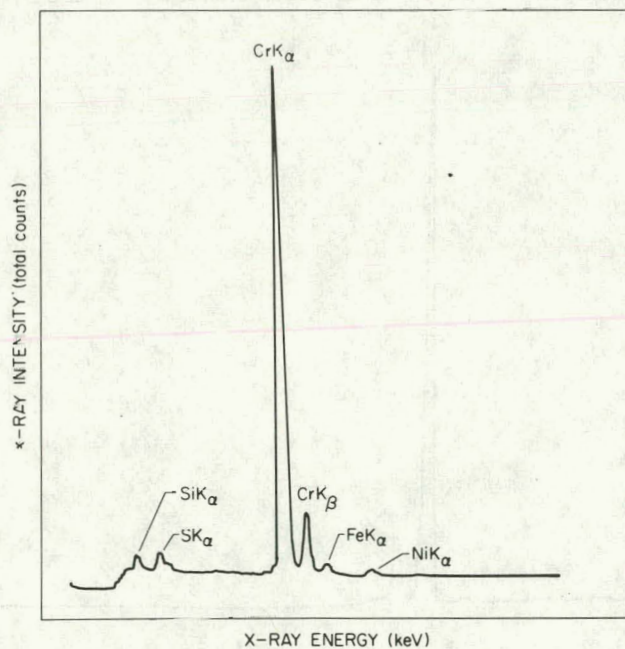
Fig. 12. Characteristic x-ray spectrum of region C corrosion product in Fig. 9.

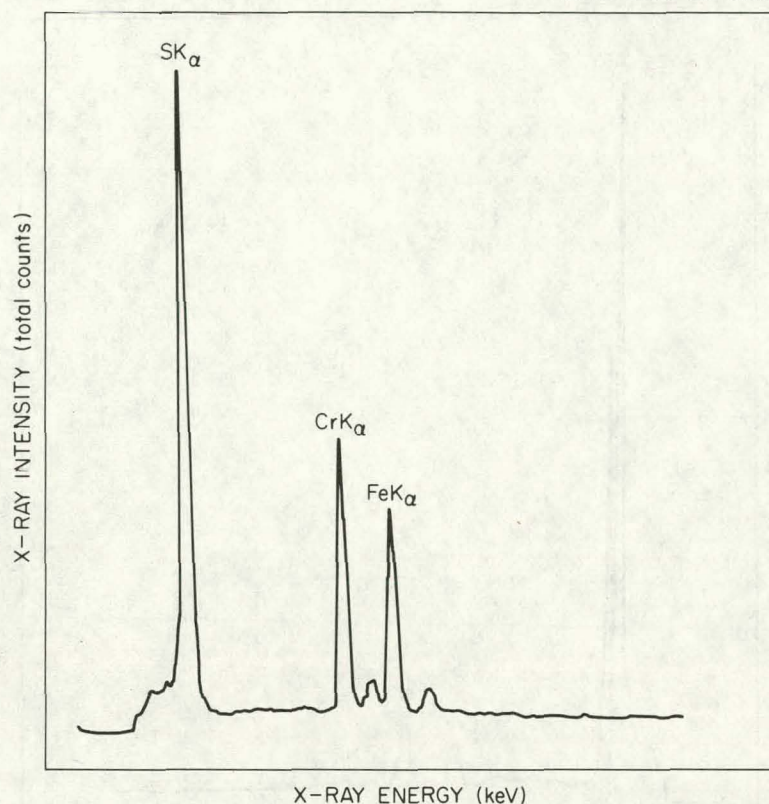
Fig. 13. Characteristic x-ray spectrum of region D corrosion product in Fig. 9.

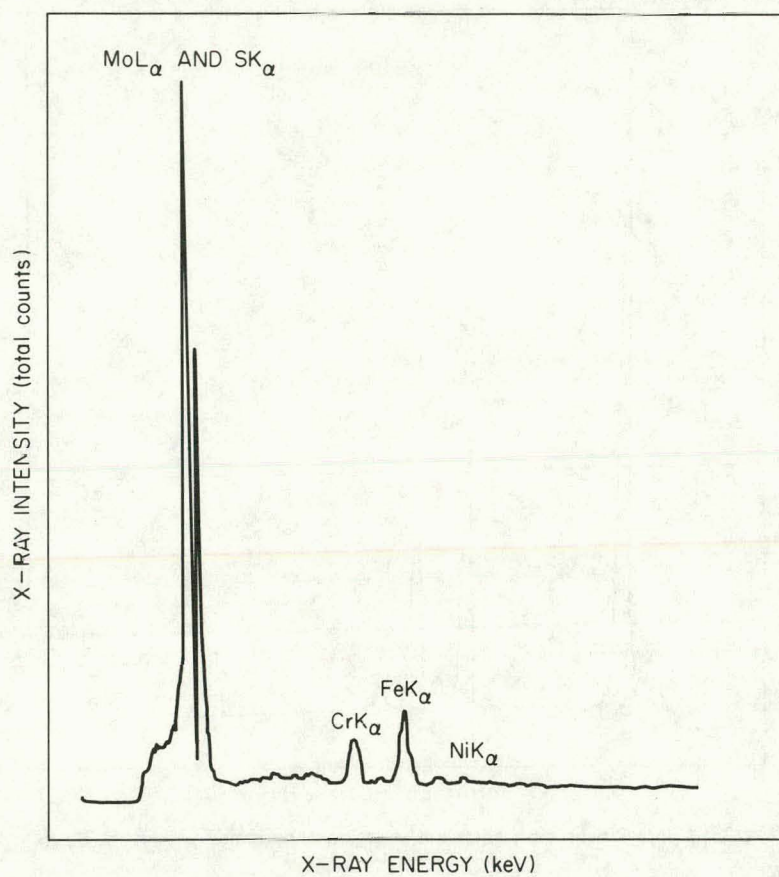
ORNL-DWG 80-8656

Fig. 14. Characteristic x-ray spectrum of region E corrosion product in Fig. 9.

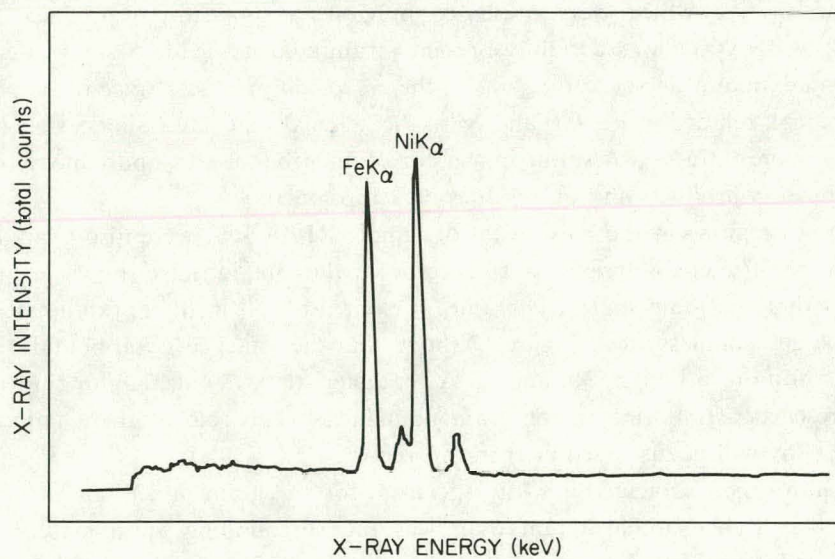
ORNL-DWG 80-8657

Fig. 15. Characteristic x-ray spectrum of region F corrosion product in Fig. 9.

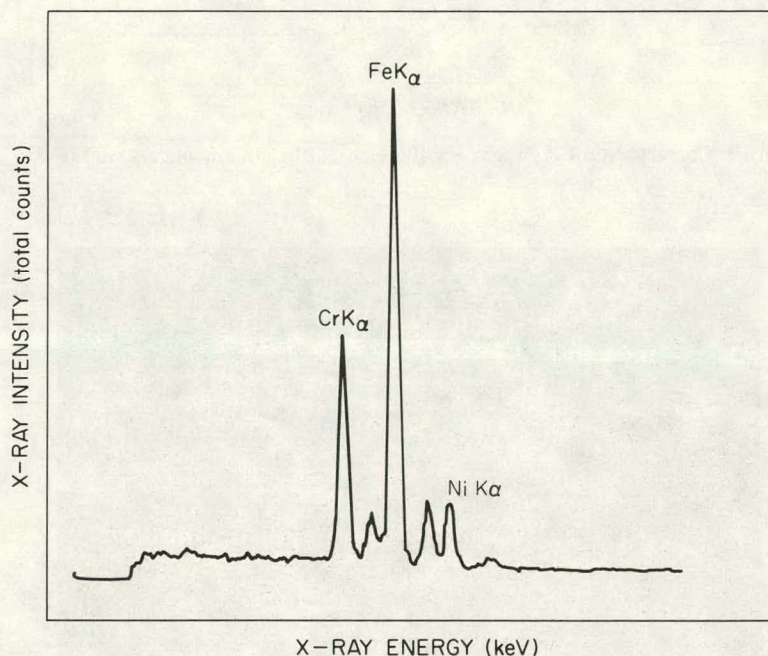
ORNL-DWG 80-8658

Figure 7 shows regions in the base metal of sample RI-3A that were also examined with the electron microprobe. The characteristic x-ray spectra for these regions are shown in Figs. 16 to 18. Figure 16 shows that the grain matrix contained Fe, Cr, and Ni in the approximate proportions expected for type 309 stainless steel. Figure 17 shows that the attacked grain boundaries contained S, Cl, and K in addition to Fe, Cr, Ni, and Si. A characteristic x-ray display for chlorine in Fig. 18 confirms the presence of chlorine in the grain boundaries. The role of these impurities on the corrosion of the alloy will be discussed later in this report.

Fig. 16. Characteristic x-ray spectrum of region G (the grain matrix) in Fig. 7.

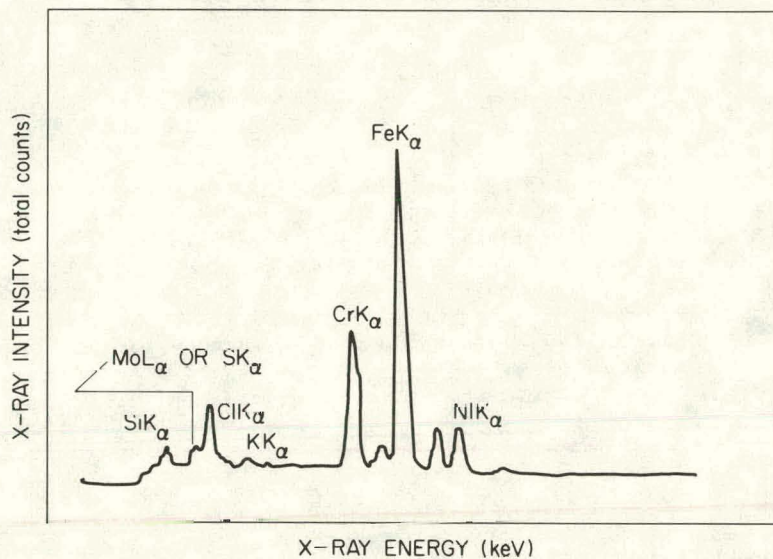
Fig. 17. Characteristic x-ray spectrum of region *H* (the grain boundary) in Fig. 7.

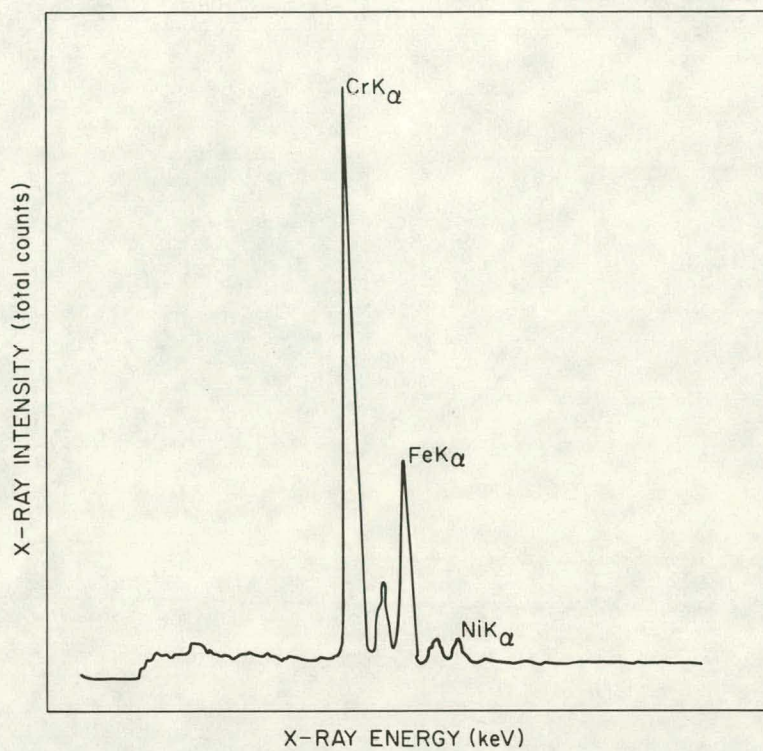
ORNL-DWG 80-8660

Figure 19 shows the characteristic x-ray spectrum for the grain precipitate in sample RI-3A. The precipitate was richer in chromium than was the surrounding grain material, as can be determined by comparison with Fig. 16. Since the grain boundaries in sample RI-3A were heavily attacked, we also examined the grain boundaries in sample RI-3B. Figure 20, the characteristic x-ray

Fig. 19. Characteristic x-ray spectrum of region I (the grain precipitate) in Fig. 7.

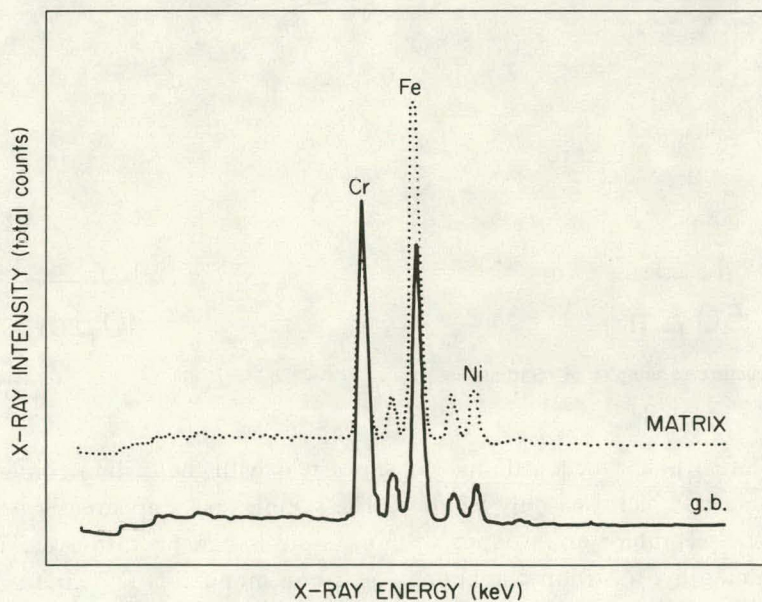
ORNL-DWG 80-8661

spectrum, shows that the grain boundaries also were richer in chromium than was the grain material. Precipitates faintly visible in as-polished samples (Fig. 7) were more clearly shown by etching. Figure 21 shows the etched microstructures of samples RI-3A and RI-3B in regions just beyond the severely attacked boundaries. These photographs show extensive grain-boundary precipitates and isolated precipitates within the grains. A special stain etch and x-ray diffraction showed that these were carbide precipitates, probably Cr_{23}C_6 . Precipitation was more extensive in sample RI-3A than in RI-3B, as can be determined by comparison of Fig. 21b (500 \times) with Fig. 21d (1500 \times). The presence of these carbide precipitates indicates either that the temperature at this location did not exceed $\sim 900^\circ\text{C}$ (1650 $^\circ\text{F}$) during the final hours of recuperator operation or that the recuperator cooled slowly in the range 900 to 500 $^\circ\text{C}$. Under normal conditions, carbides dissolve in the matrix at temperatures greater than 900 $^\circ\text{C}$. Similar precipitates were observed in other samples from the reradiant inserts and the partition wall.

Fig. 20. Characteristic x-ray spectra of grains and grain boundaries in unattacked region of sample RI-3B (see Fig. 7).

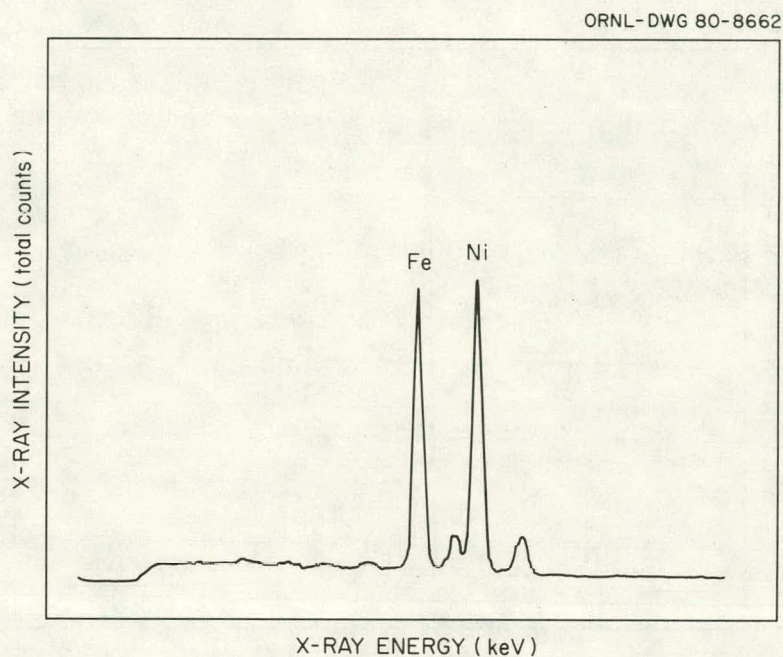
An electron microprobe study was also conducted on sample RI-24, which was initially located ~7.3 m from the bottom of the recuperator. Figures 22 to 24 show characteristic x-ray spectra of three regions in the corrosion product. These regions are identified as points *L*, *M*, and *N* in Fig. 7. Figure 22 shows that the outermost layer of corrosion product (region *L*) contained Fe and Ni in approximately equal proportions, but the adjacent region *M*, shown in Fig. 23, contained Fe, Cr, Ni, and S. Figure 24 shows that region *N* near the midthickness also contained Fe, Cr, Ni, and S, but in

Fig. 22. Characteristic x-ray spectrum of region *L* corrosion product in sample RI-24 in Fig. 7.

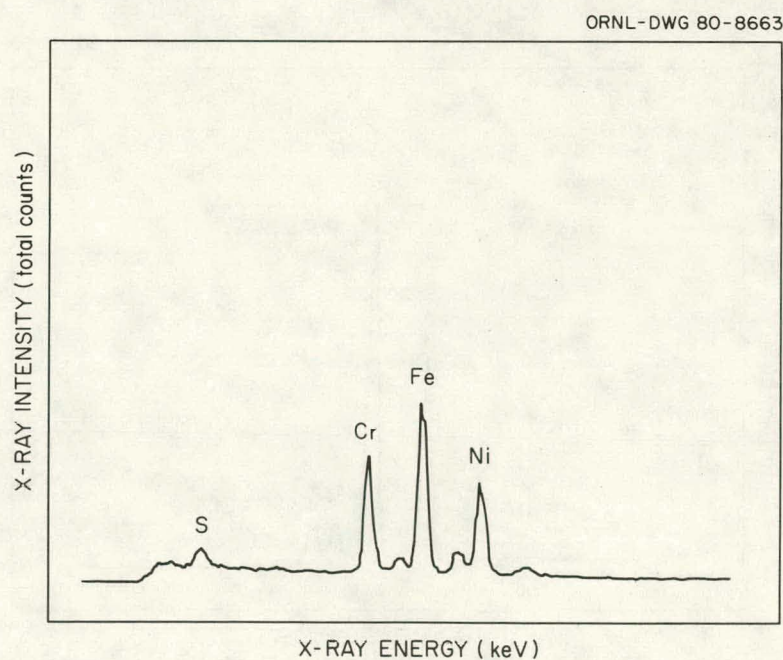
Fig. 23. Characteristic x-ray spectrum of region *M* corrosion product in sample RI-24 in Fig. 7.

this case Cr was the major element. Since regions adjacent to regions *L*, *M*, and *N* often had different x-ray spectra, Figs. 22 to 24 should be considered to be examples of the heterogeneous nature of the corrosion product. Sulfur was usually found in these x-ray spectra, indicating that this impurity was involved in the corrosion process.

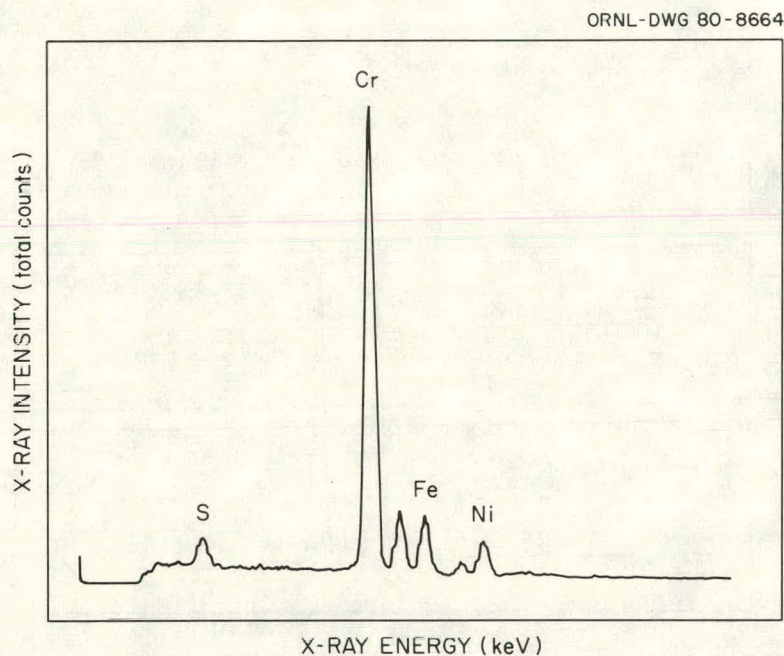
Fig. 24. Characteristic x-ray spectrum of region *N* corrosion product in sample RI-24 in Fig. 7.

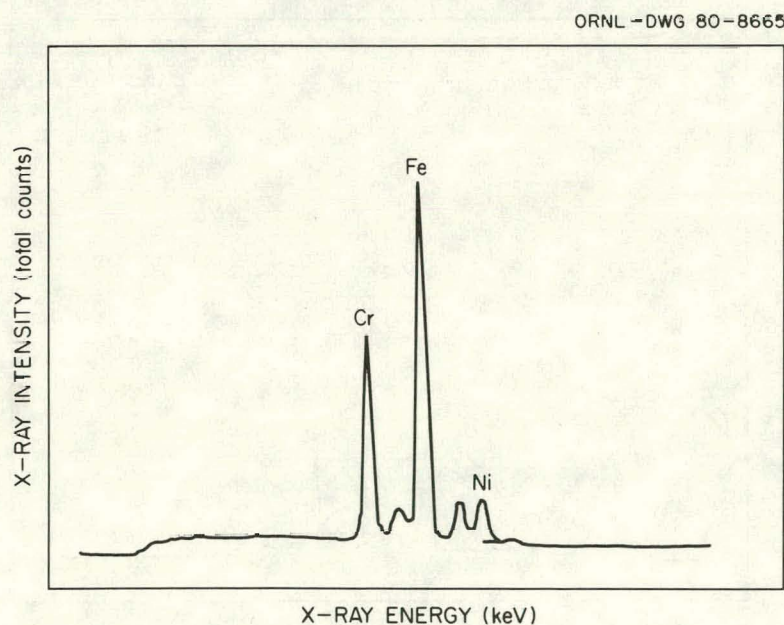
Characteristic x-ray spectra of the intergranularly corroded base metal are shown in Figs. 25 to 27. Figure 25 shows that the grain interior (region *P*) contained Fe, Cr, and Ni as expected.

Fig. 25. Characteristic x-ray spectrum of grain in region *P* in sample RI-24 in Fig. 7.

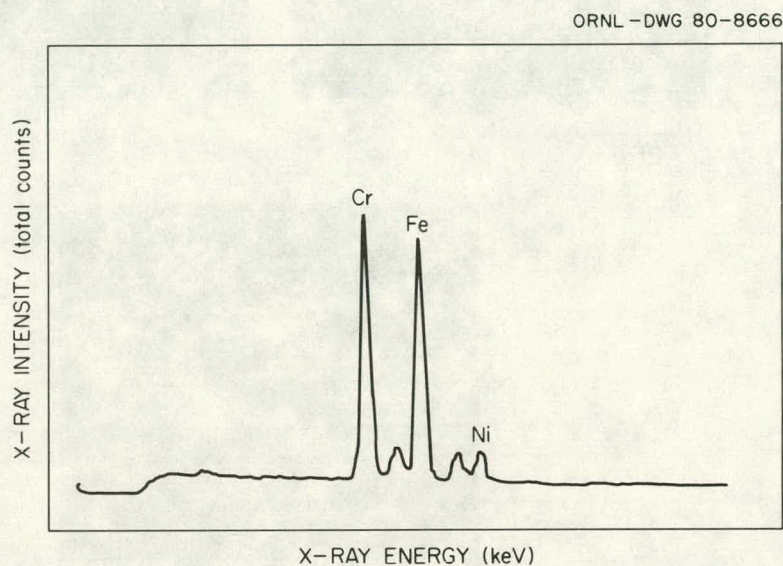
Grain-boundary region *Q*, shown in Fig. 26, also contained Fe, Cr, and Ni (higher Cr concentration than in region *P*); and grain-boundary region *R*, shown in Fig. 27, contained Fe, Cr, Ni, and S. Characteristic x-ray displays for Cl, K, and S shown in Fig. 28 reveal that these impurity elements were concentrated in the grain boundaries in the intergranularly attacked material.

Fig. 26. Characteristic x-ray spectrum of grain-boundary region *Q* in sample RI-24 in Fig. 7.

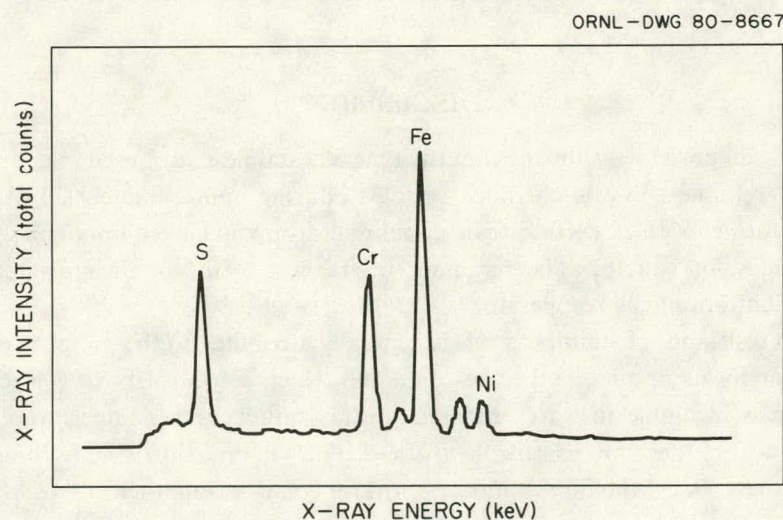
Fig. 27. Characteristic x-ray spectrum of grain-boundary region *R* in sample RI-24 in Fig. 7.

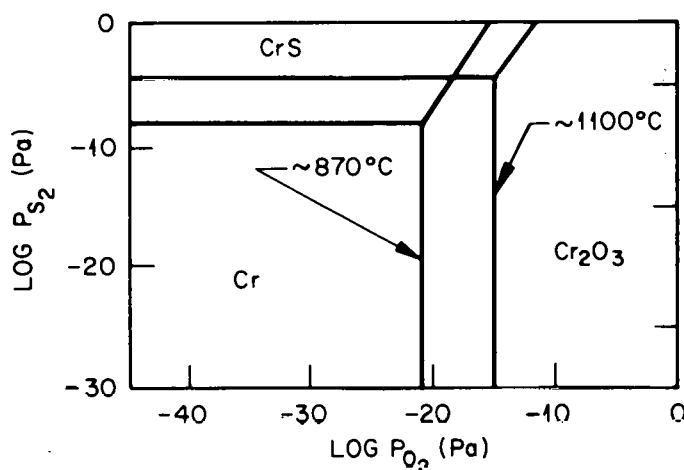
The available evidence indicates that the corrosion mechanism was sulfidation-oxidation. This corrosion process, which has been described by Stringer and Whittle⁶ and by Stringer,⁷ has been observed in iron- and nickel-based alloys in fluidized-bed combustors and in utility equipment using fossil fuels. Corrosion is governed by the thermodynamic stability of the oxides and sulfides of the elements involved. Figure 29 shows the limiting oxygen and sulfur partial pressures for stability of Cr_2O_3 and CrS at temperatures of ~ 870 and $\sim 1100^\circ\text{C}$. These temperatures are used for illustrative purposes and do not necessarily refer to actual known temperatures in the recuperator. Since the oil flame temperature is estimated to be $\sim 2100^\circ\text{C}$,⁸ the temperatures used in Fig. 29 are not unreasonable. This type of diagram was calculated by Hemmings and Perkins,⁹ who have also constructed similar diagrams for Fe, Ni, and Mn at different temperatures. If the combustion products at 870°C , for example, contained $p_{\text{O}_2} > 10^{-21}$ Pa and $p_{\text{S}_2} < 10^{-8}$ Pa, the stable phase would be Cr_2O_3 . In the case of stainless steel, the oxide film would contain Cr_2O_3 and would be protective. The value of p_{O_2} decreases from the ambient value to 10^{-21} Pa at the Cr- Cr_2O_3 interface (or the stainless steel-oxide film interface). If the oxide film on the stainless steel is completely transparent to sulfur, then the value of p_{S_2} at the interface would equal the ambient value. Thus an increase in p_{S_2} in the combustion products could shift the equilibrium at the interface in favor of CrS instead of Cr_2O_3 . This is equivalent to loss of the protective oxide film, and without the protective film the alloy corrodes relatively rapidly.

Some characteristics of this type of corrosion have been described by Stringer and Whittle.⁶ Sulfides form ahead of the oxidation front and prevent formation of a continuous protective oxide

Fig. 29. Phase relationships in the Cr-O-S system.

film. As a result the alloy oxidizes. A self-perpetuating situation develops when oxidation of the sulfides releases sulfur, which diffuses further into the alloy and forms more sulfides.
